June 13, 2017

Radioactive contamination at Plutonium Fuel Research Facility (PFRF) in Oarai  
Research and Development Center (Follow-up 3)

Japan Atomic Energy Agency

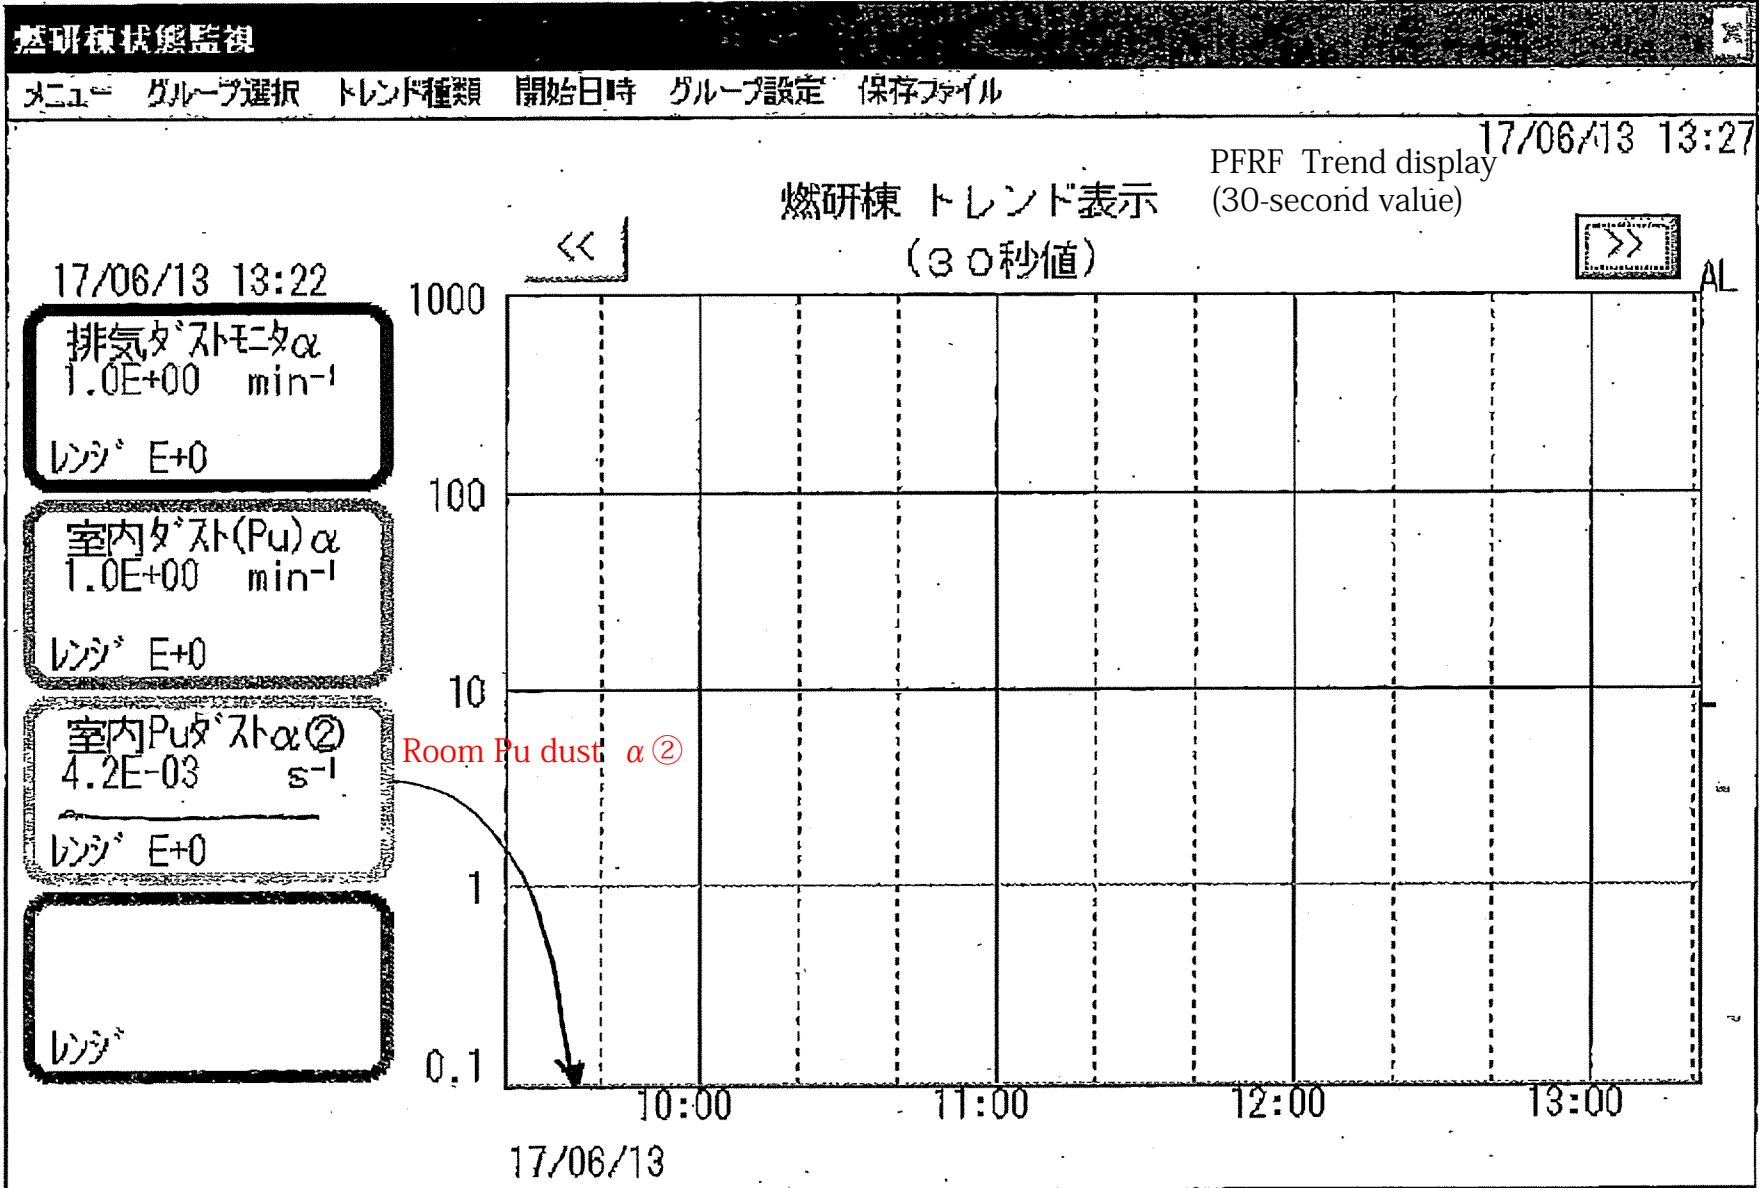
Room Pu dust α② Indicated value is within the range of normal (<0.1 s<sup>-1</sup>).  
→Vertical axis range switched. →Attachment②

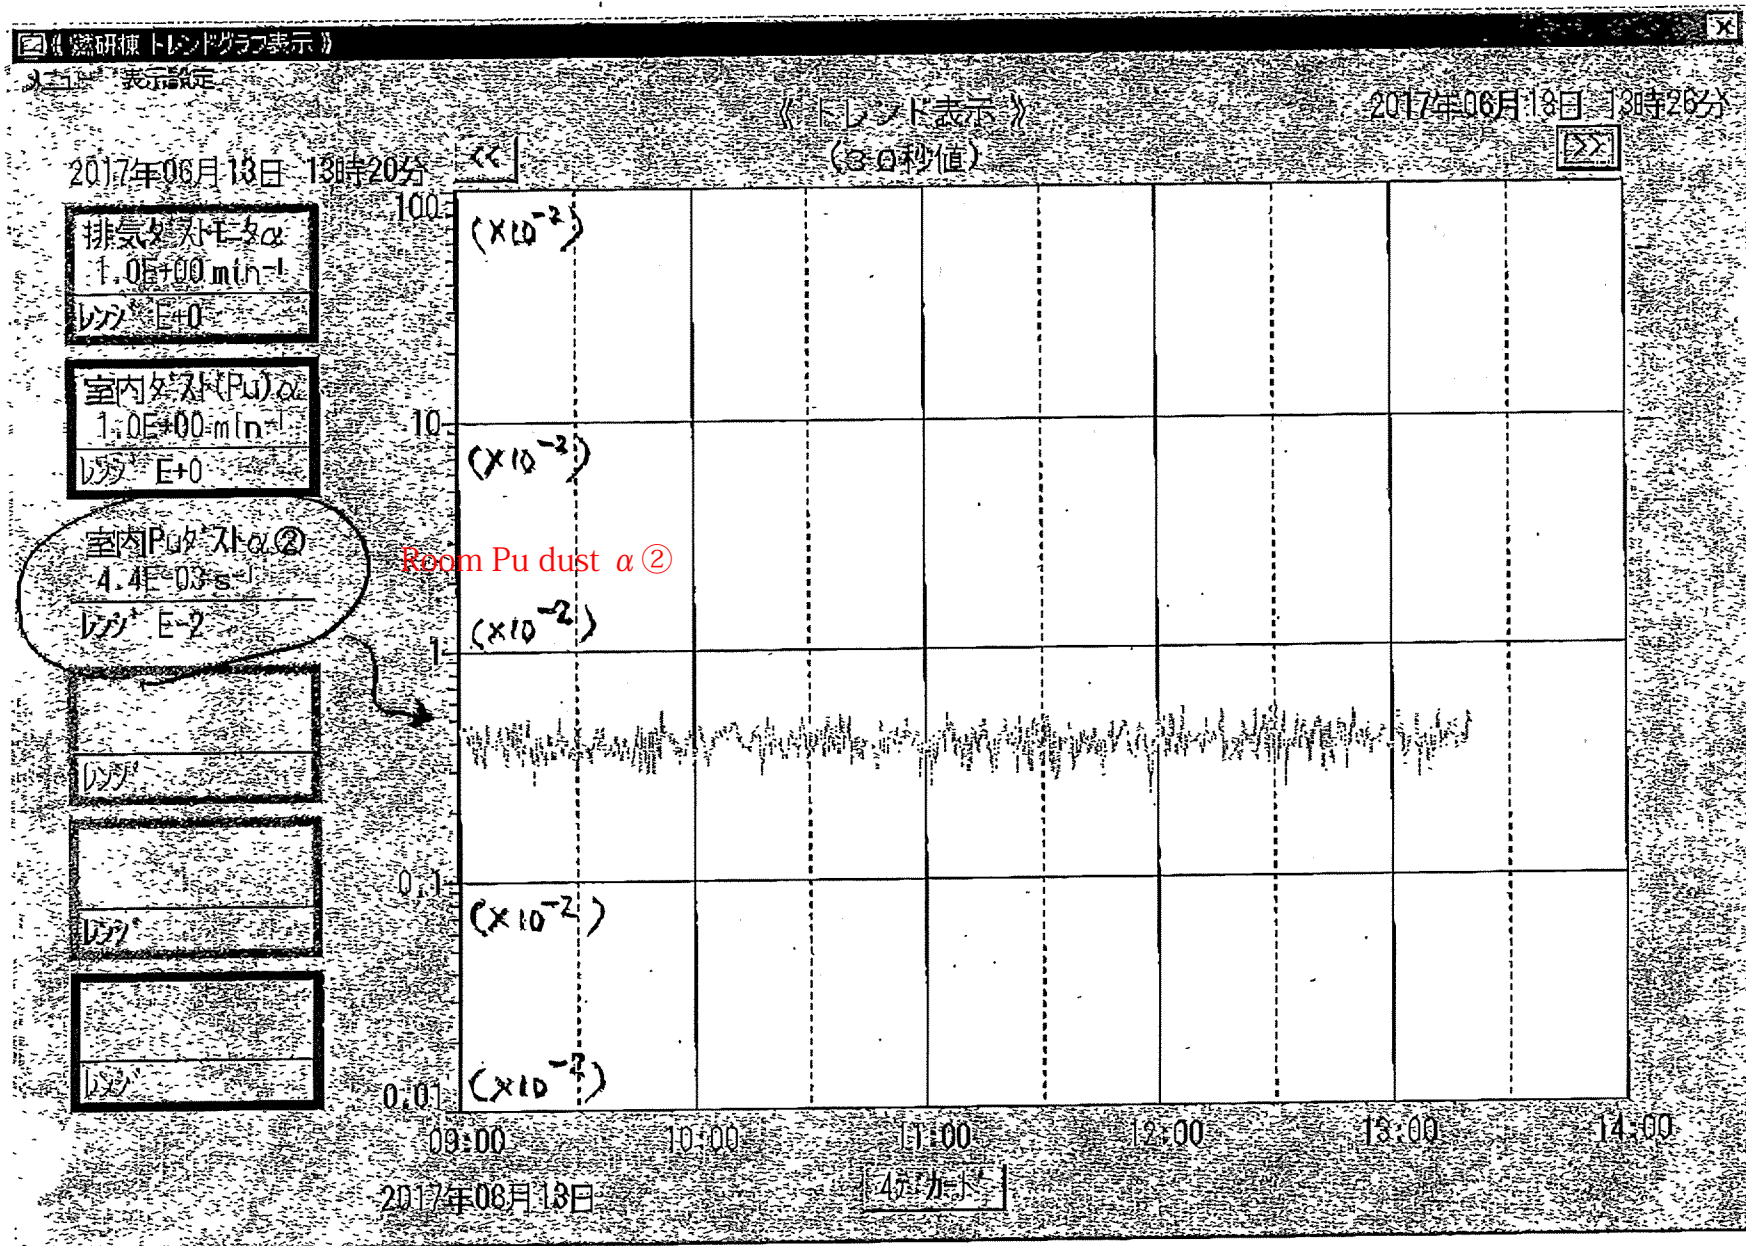
Room Pu dust α ② Indicated value is within the range of normal. (<0.1 s<sup>-1</sup>)
